## **Werndale Hospital**

## **Unannounced Cleanliness Spot Check**

**Date of visit 22 February 2012**

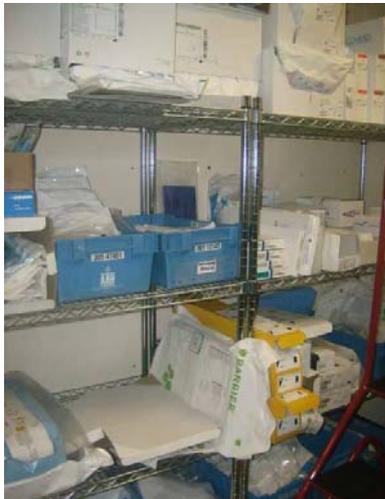
- New shelving has been placed in the sterile room which enables cleaning to be carried out more effectively.

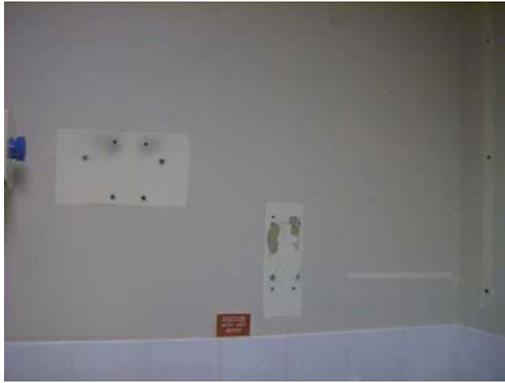
- Within the dirty utility and sterile store room items had been removed from the walls leaving visible holes, these should be filled so that the areas can be cleaned appropriately.

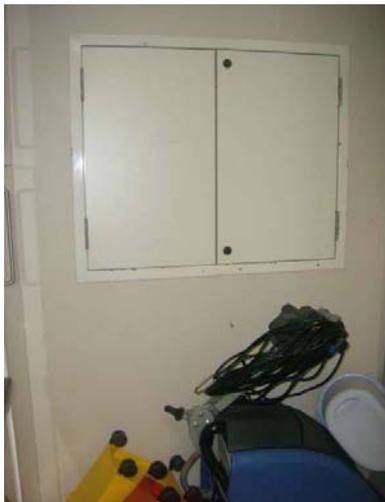
- There is a hatch in the dirty utility which is used to transfer dirty theatre trays. However, these are being passed over the cleaning equipment which is being stored in the dirty utility. This is unacceptable. All cleaning equipment should be removed as the current practice gives rise to a risk of contamination.

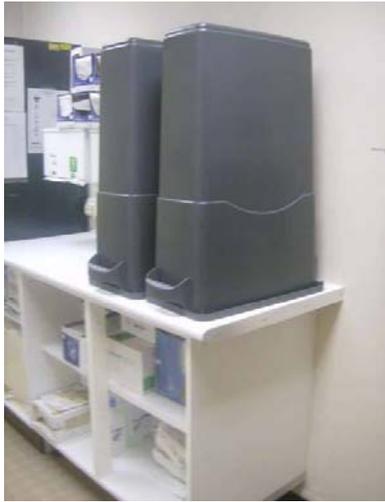
- While not in use, waste bins in the scrub area were being stored on the worktop. Waste bins should not be stored on worktops and should be removed.

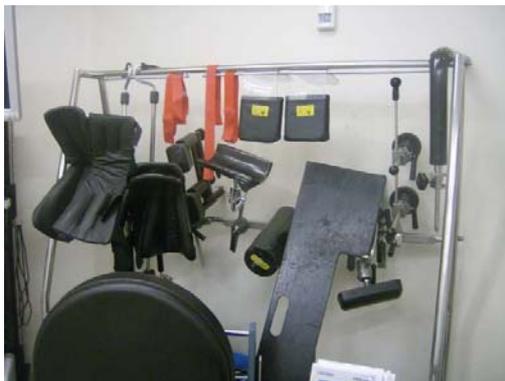
- Equipment was being stored in the theatre room while not in use. These should be removed and stored appropriately.

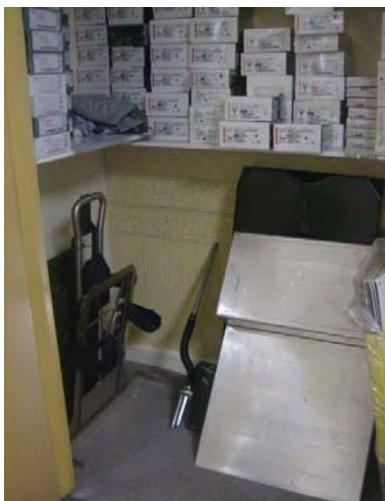
- Sterile stock along with other equipment was being stored in the theatre store room. A more suitable method of storing items should be put in place in order to separate the sterile stock from the other items.

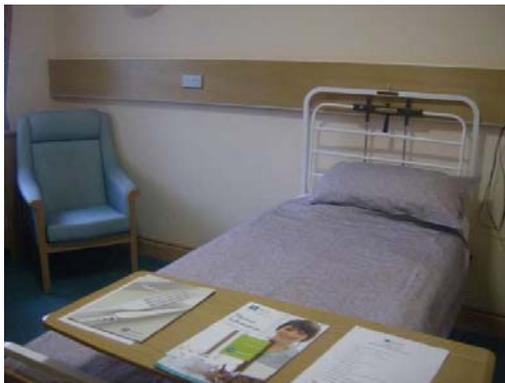
- The hospital should consider replacing the carpet with flooring that can be easily cleaned as carpet is not conducive to effective cleaning.

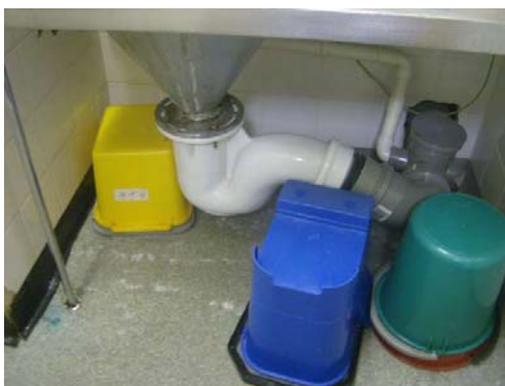
- Within the domestic room cleaning buckets were being stored on the floor, this is unacceptable. Buckets should be removed from the floor and stored appropriately above floor level.

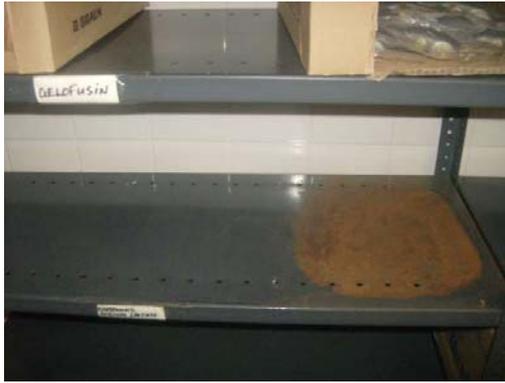
- Shelving within the clinical room was found to be damaged which is not conducive to effective cleaning and should be replaced.

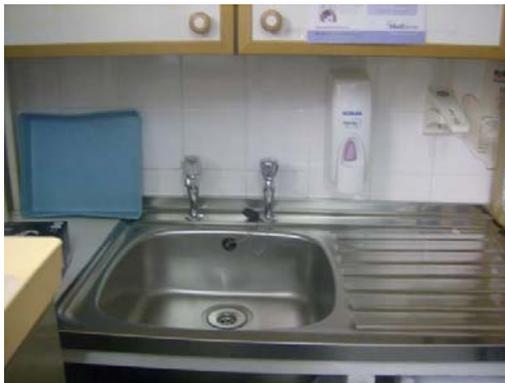
- The hand washing sink in the clinical room does not conform to Health Technical Memoranda (HTM) 64 as the sink has a plug, an overflow and incorrect taps. An appropriate dedicated clinical hand washing sink should be available for staff.

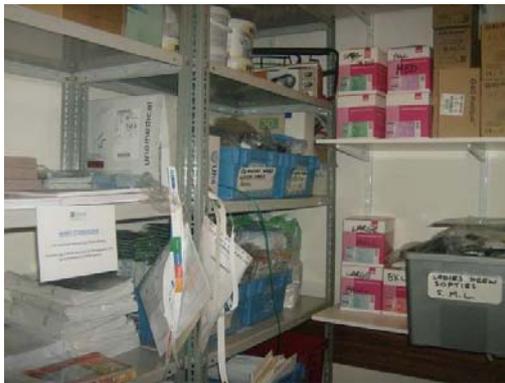
- Sterile stock along with paperwork and equipment was being stored in the clinical store room. A more suitable method of storing items should be put in place in order to separate the sterile stock from the other items.
