## **Powys Teaching Local Health Board**

### **Unannounced Cleanliness Spot Check**

**Date of visit    15 March 2011**

1.5 On 15 March 2011 HIW visited Machynlleth Community Hospital which is part of Powys Teaching Local Health Board and undertook a cleanliness spot check of the Twymyn Ward, Rehabilitation Ward.

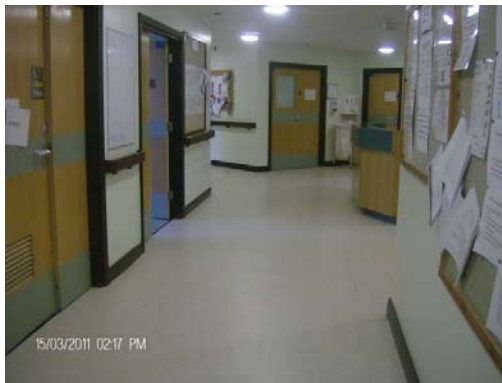
We found the ward to be of a good standard of cleanliness, free from high and low level dust.
